# West Lake

## Aquatic Vegetation Report, 2021

Quinte  
CONSERVATION

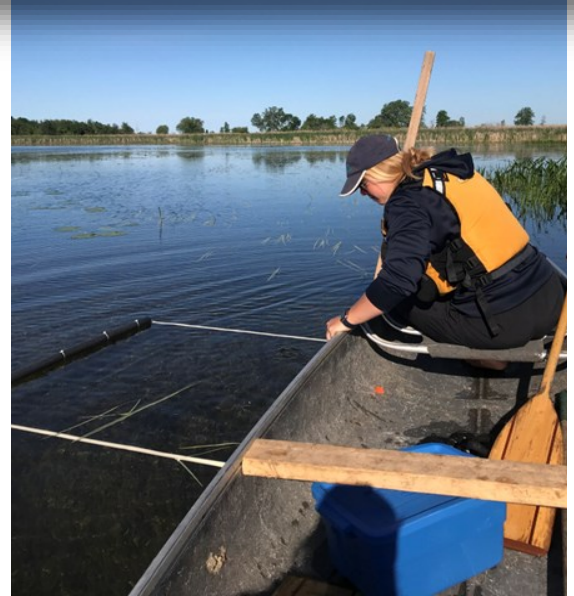
*The surveys of submerged aquatic vegetation (SAV) used a random point method, within predetermined areas with SAV (i.e. Wetlands). Random points were generated before sampling. Sites were then surveyed for an inventory of SAV and their aerial coverages within 1x1 meter quadrats.*

*Plants were recorded from the surface to substrate (a 3-dimensional space) while being ranked according to the area bounded by the quadrat. This method captures the species occurrences and percent cover.*

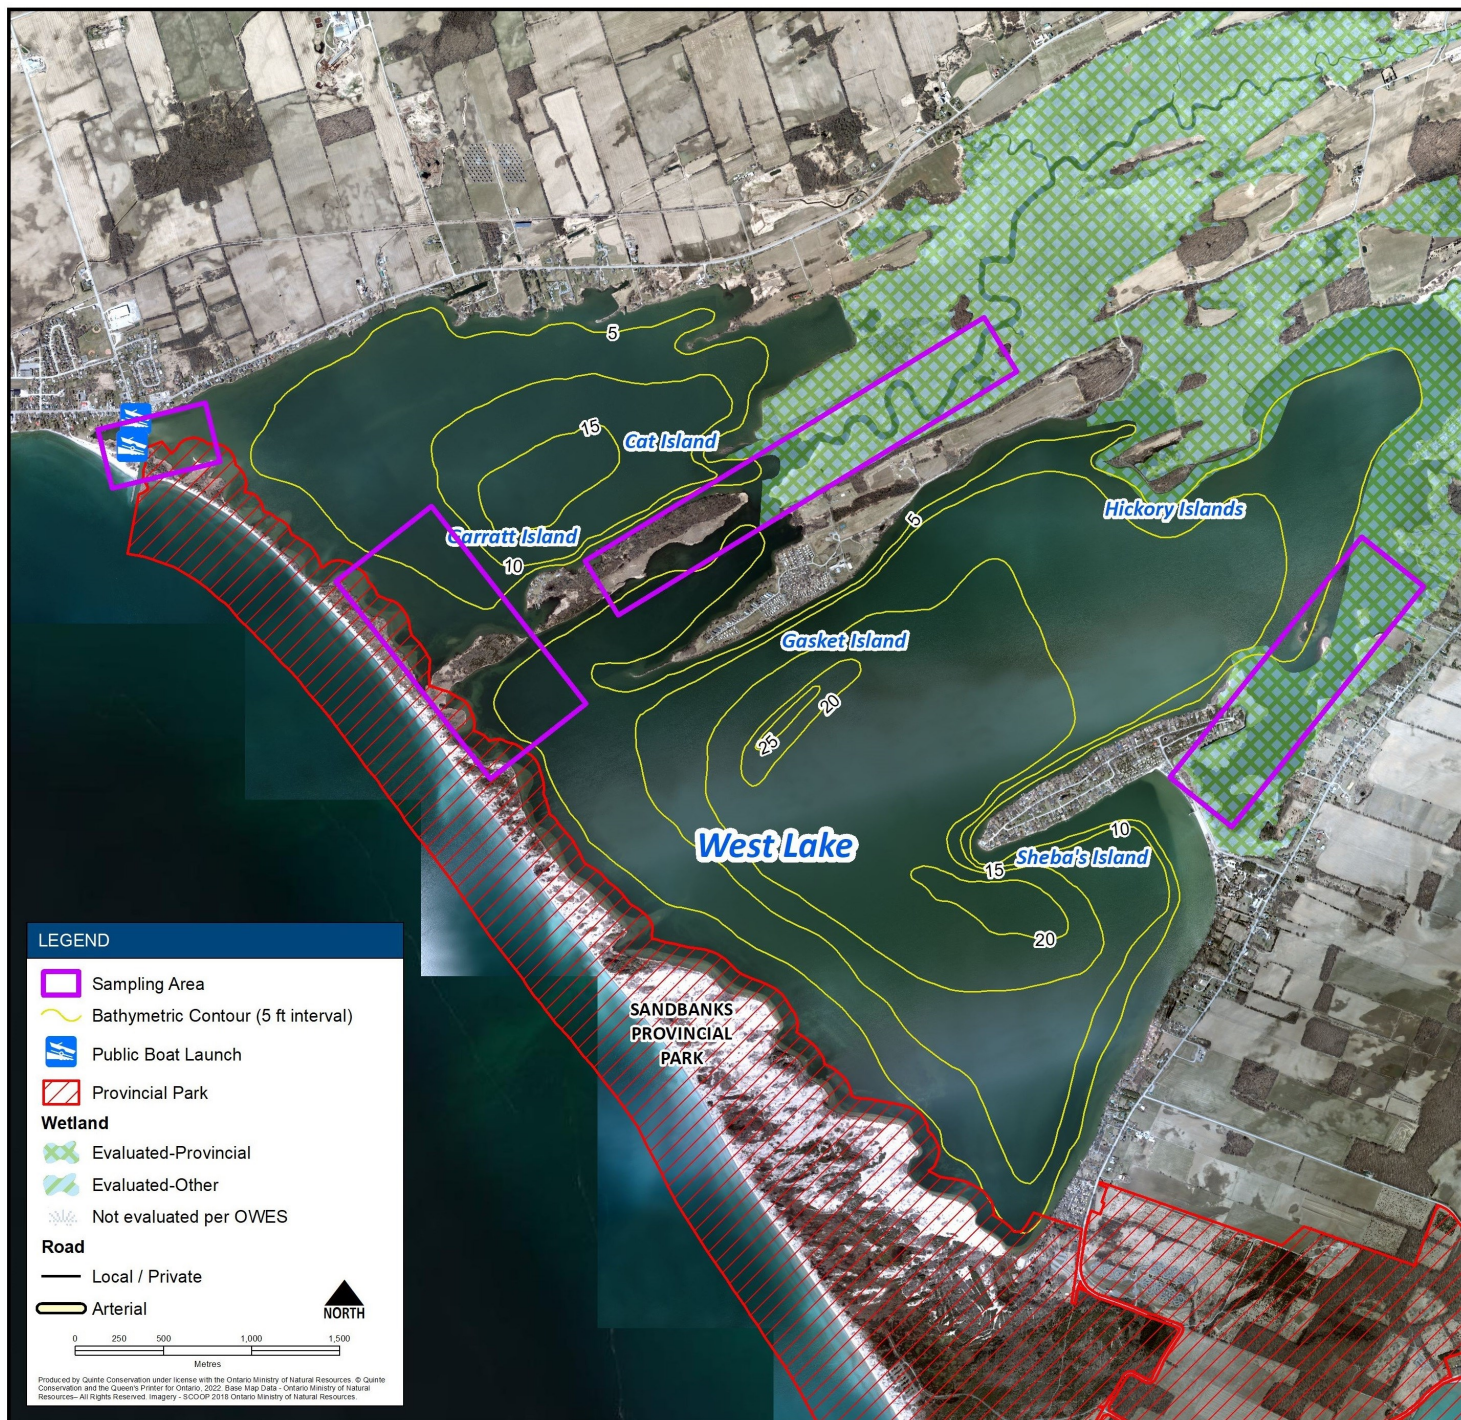
## Map 1: West Lake 2021 Vegetation Survey Locations

Submerged Aquatic Vegetation (SAV) surveys took place in the summer of 2021. Separate zones were surveyed across West Lake and within each zone, 60 randomized sampling locations were surveyed for vegetation species and percent coverage. *See Map 1 for survey locations.*

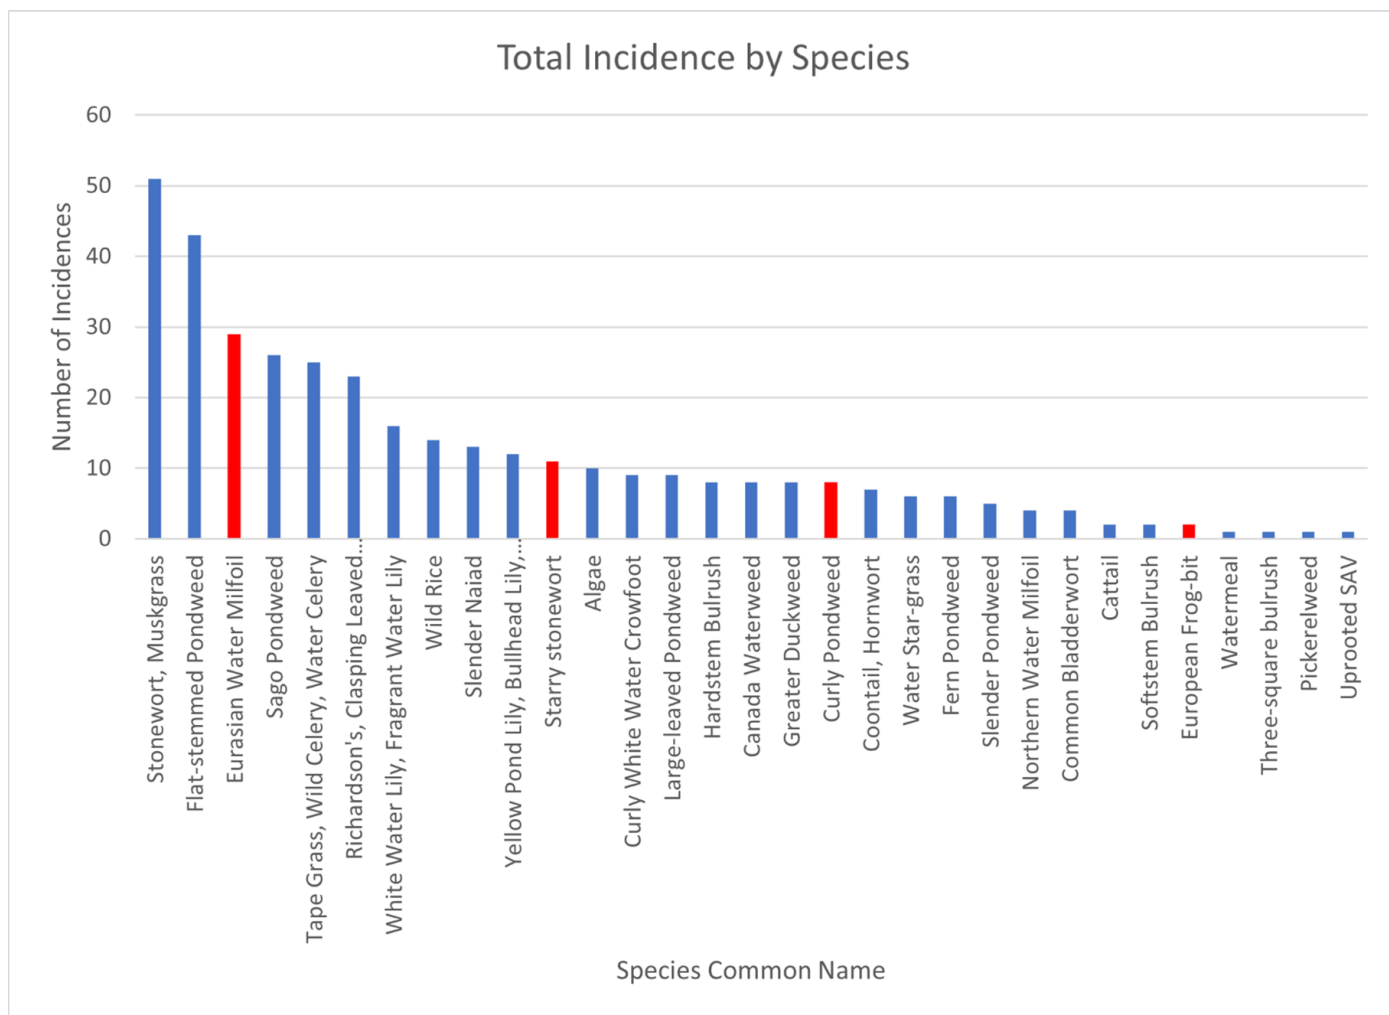
Figure 1: Incidence of all aquatic plant species documented within surveyed quadrats, 2021.

The figure below displays all aquatic plant species documented during the survey (2021) and the total number of quadrats they were observed in (out of 60). Documented species are ranked from most to least abundant and includes both submergent and emergent plants.

Invasive species are highlighted in red, while native species are blue.

31 species of aquatic vegetation were inventoried within the studied quadrats, with four of the aquatic plants identified as non-native invasive plants. An additional three invasive plant species of concern were noted outside of the quadrats inventoried, Invasive phragmites (*Phragmites australis*), Purple loosestrife (*Lythrum salicaria*), and Flowering rush (*Butomus umbellatus*).
